CONNECTICUT RIVER BASIN
DEEP RIVER, CONNECTICUT

ROGERS POND DAM
CT 00428

PHASE 1 INSPECTION REPORT
NATIONAL DAM INSPECTION PROGRAM

APRIL 1981

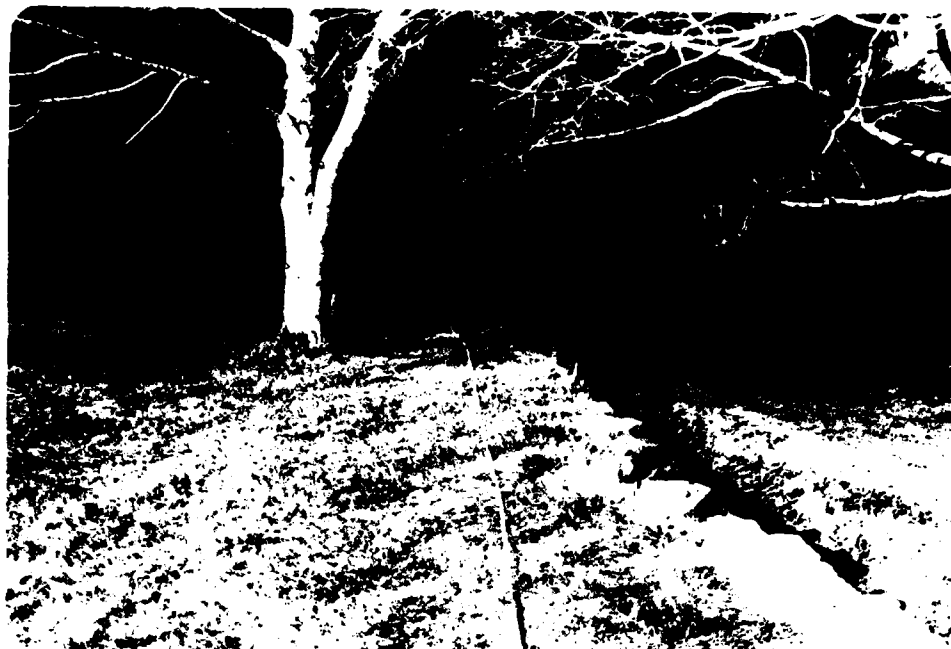
7. Edge of spillway looking toward left side of dam.
